FINAL REPORT  
BARRINGTON TOWN OFFICES  
STUDY FOR REMEDIATION,  
RENOVATION OR RELOCATION

FOR  
THE TOWN OF BARRINGTON, NEW HAMPSHIRE

FEBRUARY 2011

THE H. L. TURNER GROUP Inc.

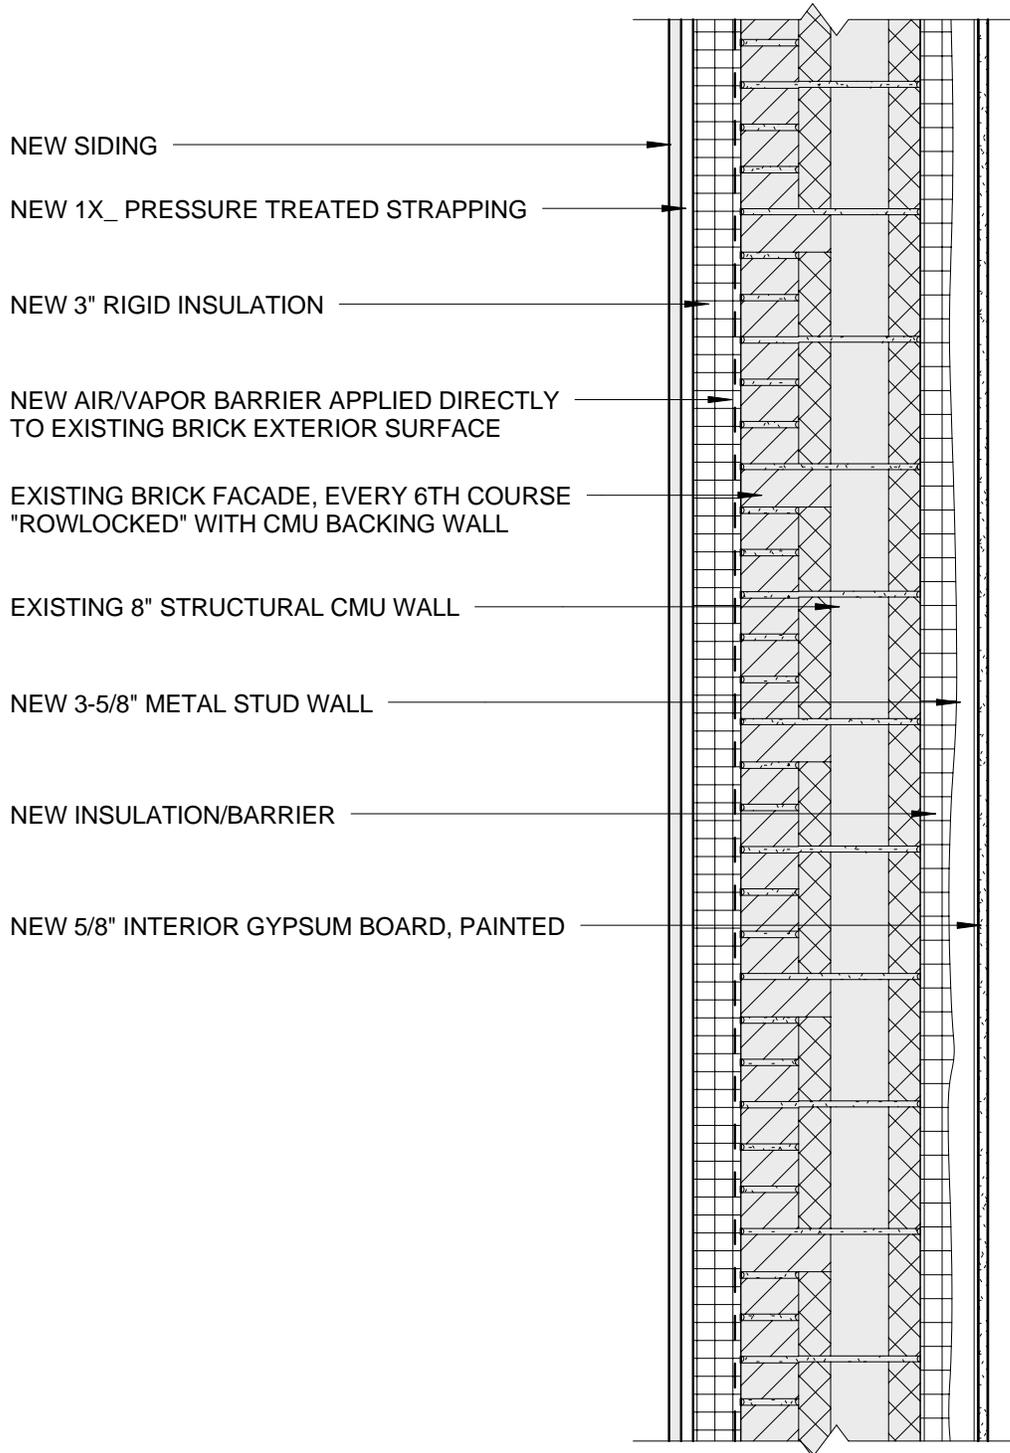
- NEW SIDING
- NEW 1X\_ PRESSURE TREATED STRAPPING
- NEW 3" RIGID INSULATION
- NEW AIR/VAPOR BARRIER APPLIED DIRECTLY TO EXISTING BRICK EXTERIOR SURFACE
- EXISTING BRICK FACADE, EVERY 6TH COURSE "ROWLOCKED" WITH CMU BACKING WALL
- EXISTING 8" STRUCTURAL CMU WALL
- NEW 3-5/8" METAL STUD WALL
- NEW INSULATION/BARRIER
- NEW 5/8" INTERIOR GYPSUM BOARD, PAINTED

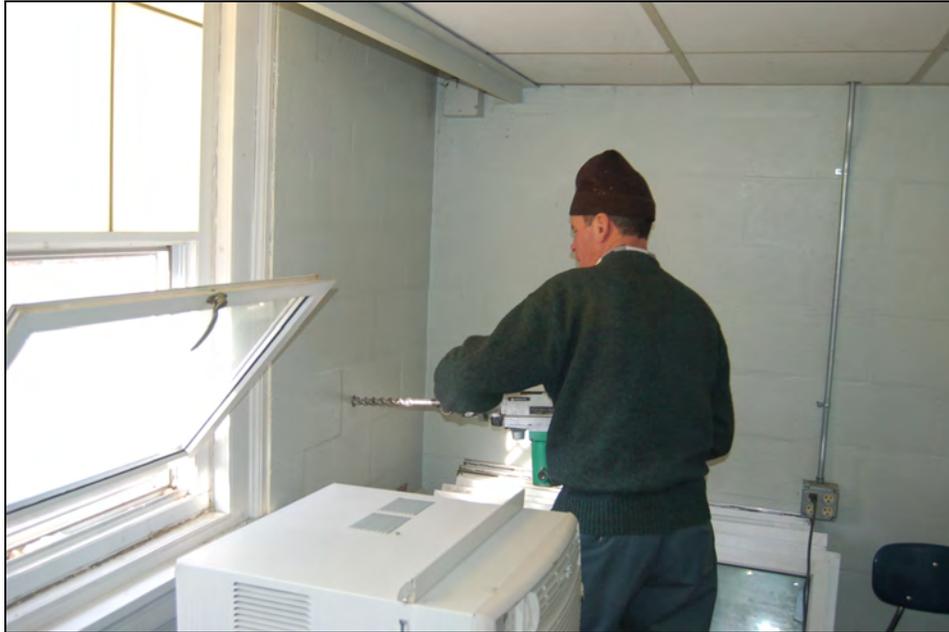
Drilling holes through the CMU.

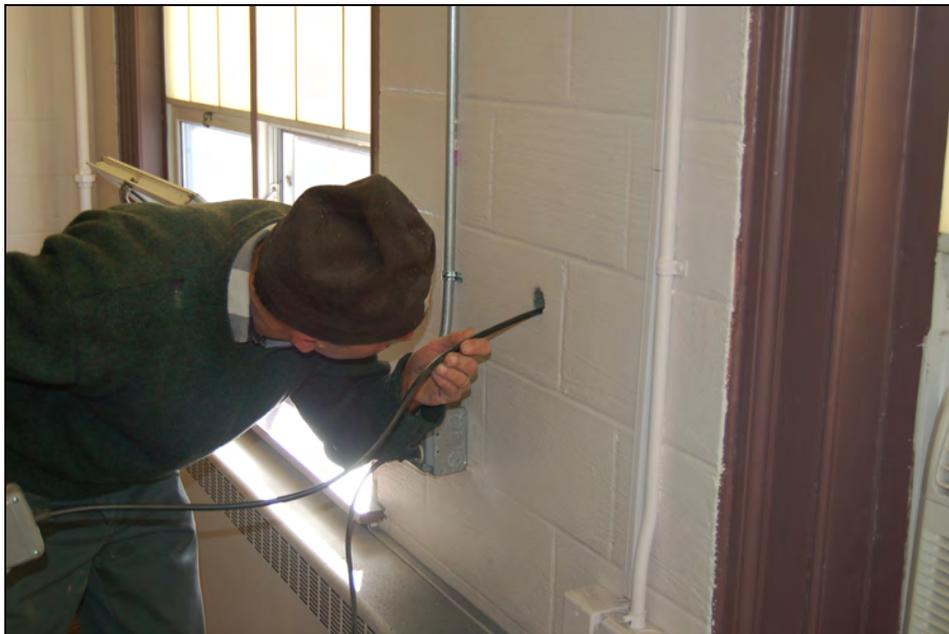
Using a camera probe to view the wall cavity.

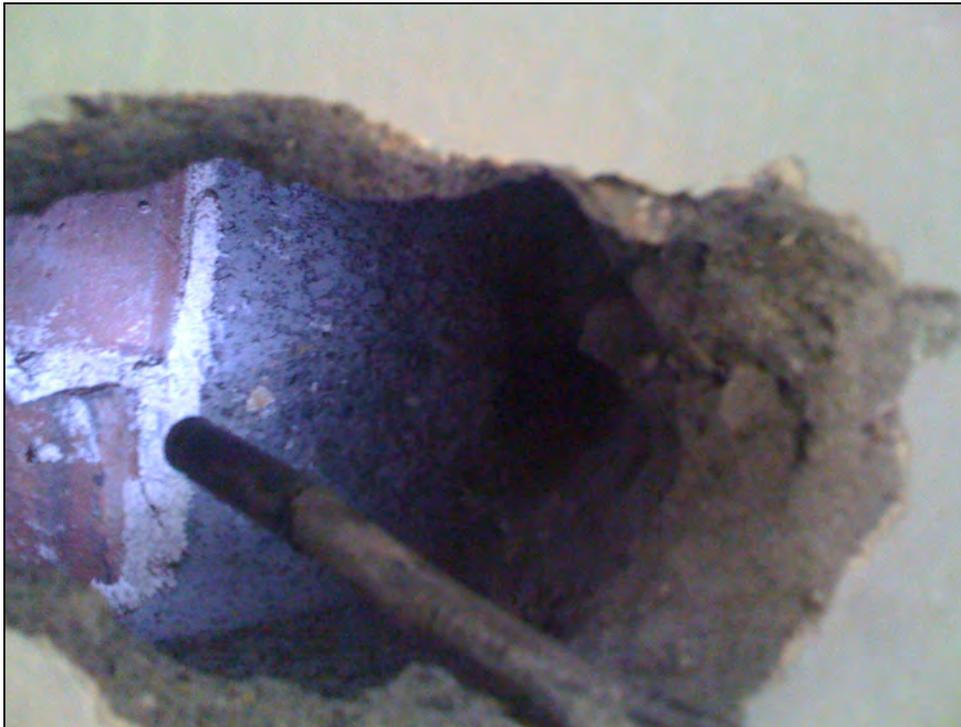
Core of CMU block; visible brick is tie to brick veneer.

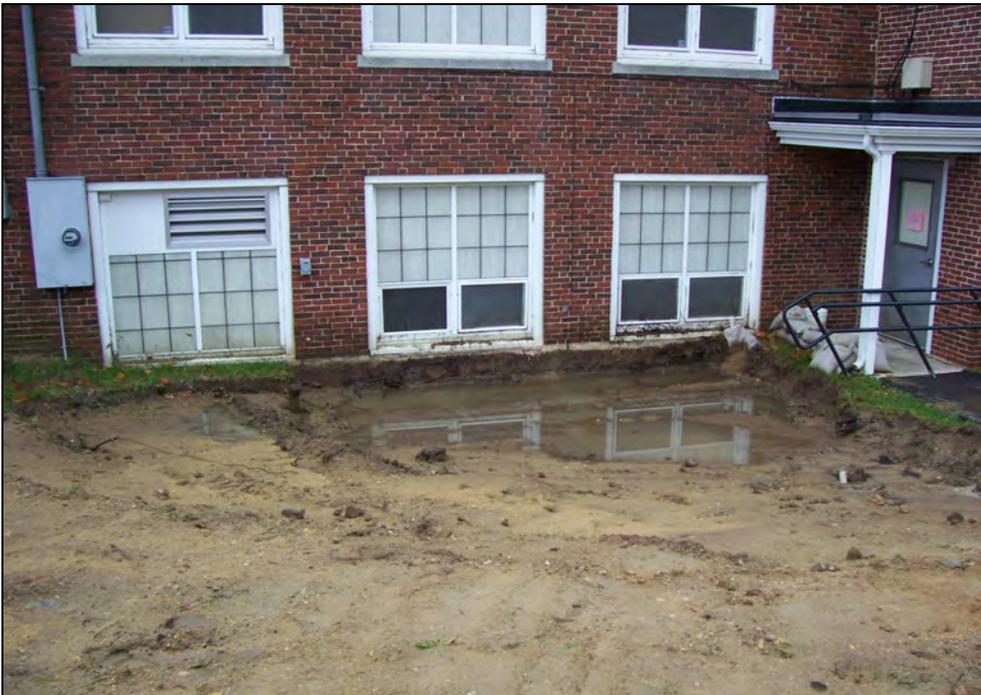
Civil Photo 12: Finished grade at windows and door pad.

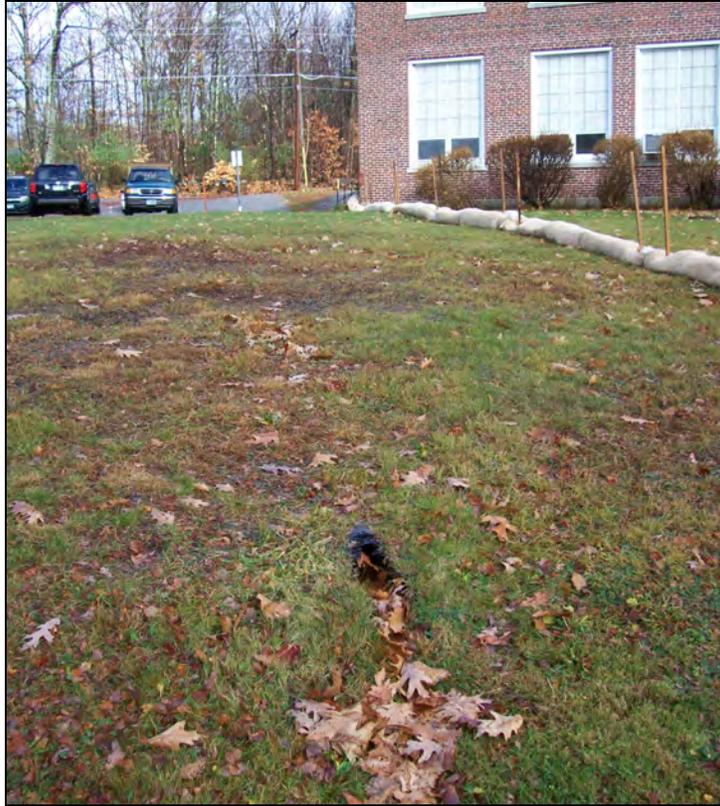
Civil Photo 13: Existing outlet from drop inlet.

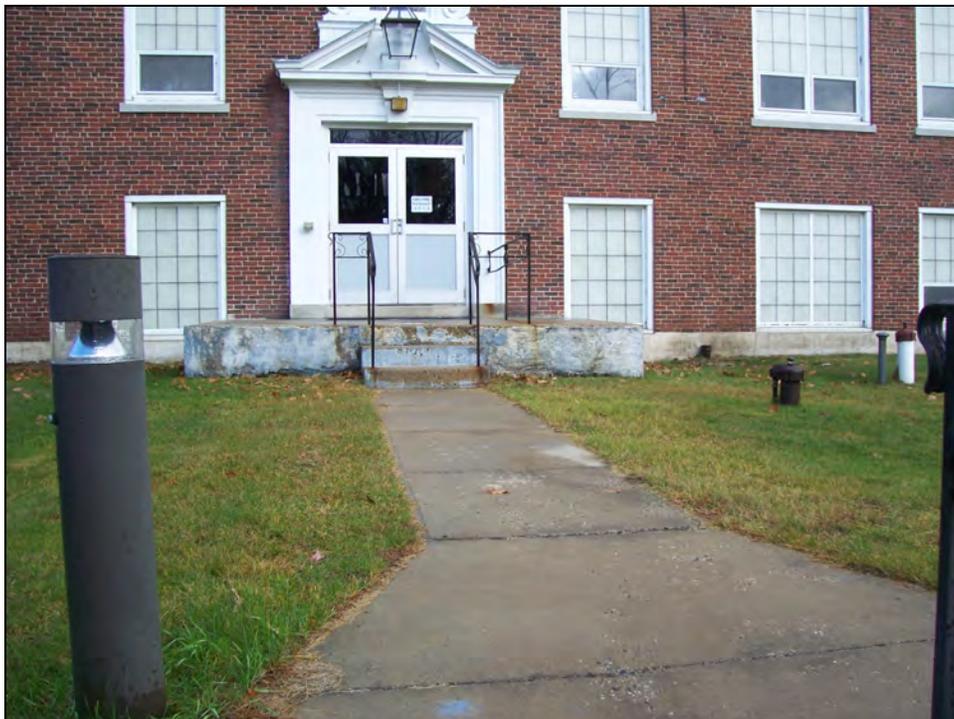
Civil Photo 14: Existing stairs at employee entrance.

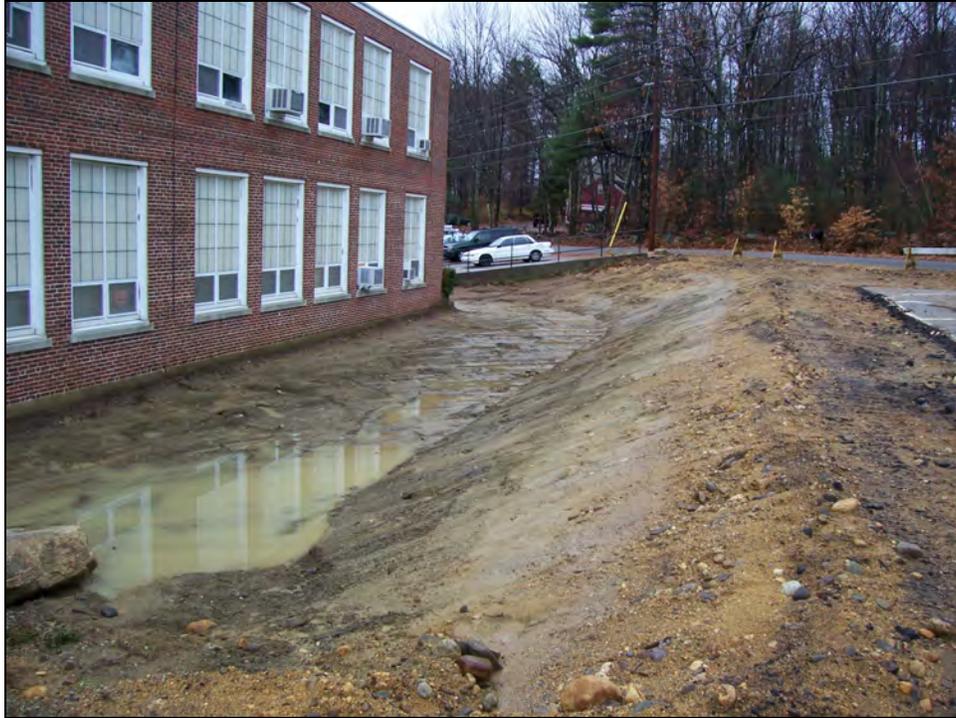
Civil Photo 15: Slope between building and upper parking lot.

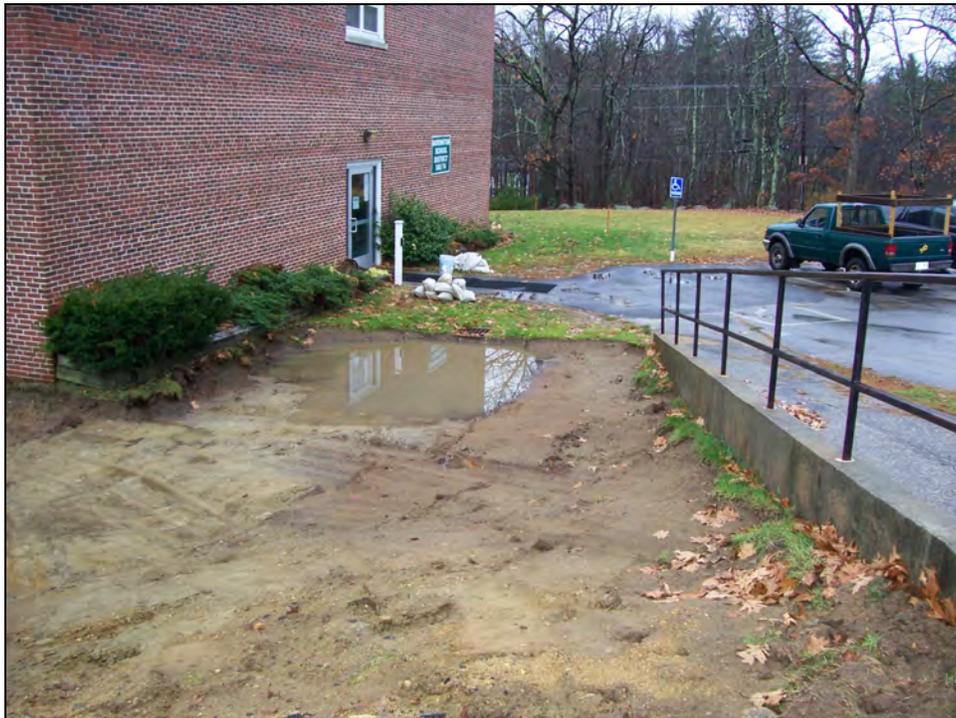
Civil Photo 16: Existing drop inlet and non-ADA compliant handrail.

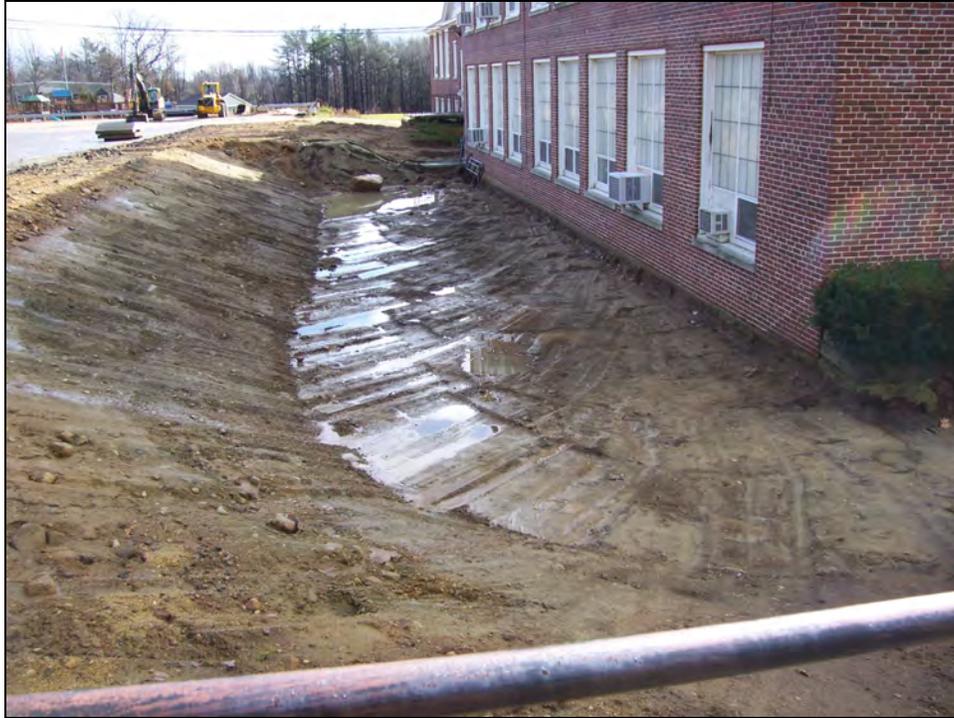
Civil Photo 17: Drainage improvements in progress (fall 2010).
